Pre Purchase Inspections

Pre-purchase Visual

Weather-tightness

Report

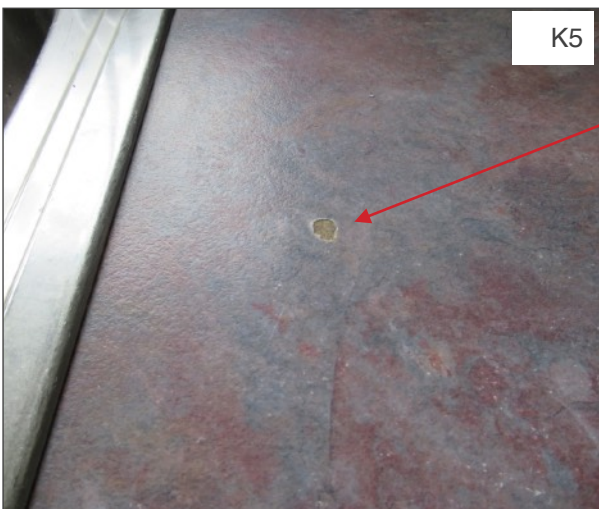
K5

Bench top

Damage to the surface of the bench top noted to the right of the sink

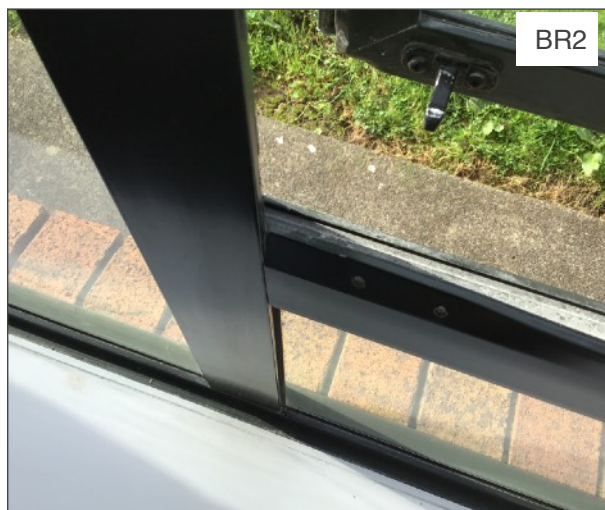
General

Historic damage found on this joinery that does not affect performance

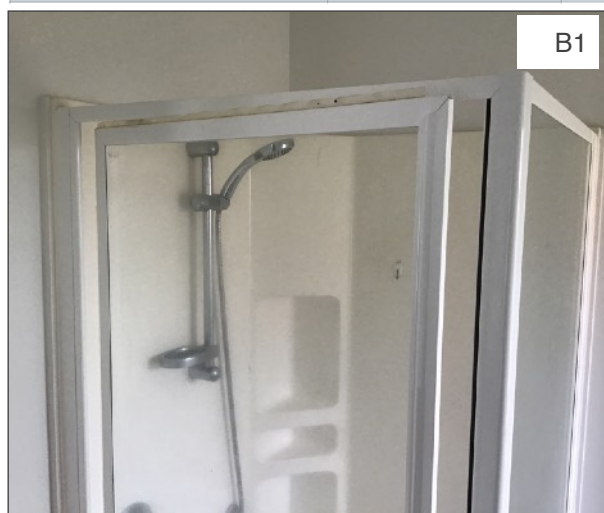
B1

Shower

The shower door has been installed upside down. The seal that should be at the bottom of the door can be seen at the top

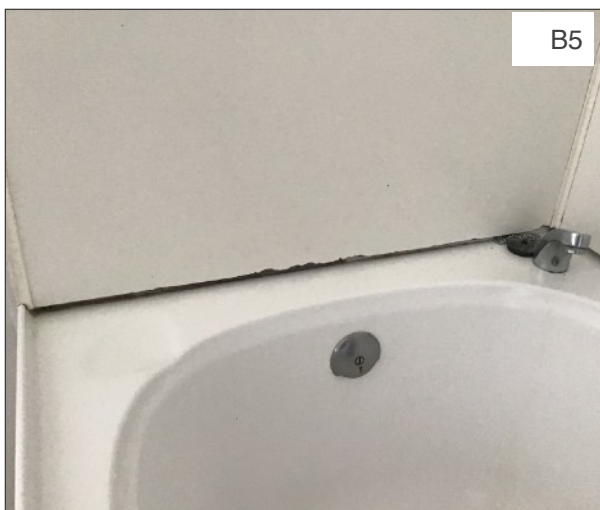
Shower

The shower liners have started to deteriorate and will need to be replaced soon

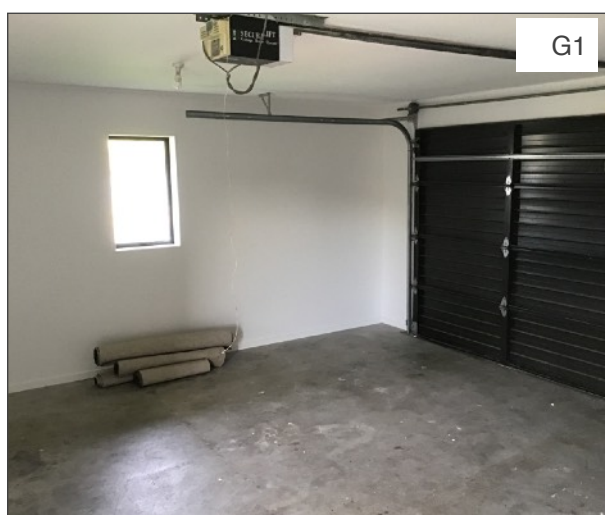
General

No water ingress issues found at time of inspection
General condition is good for the age of the dwelling

The estate agent confirmed the garage door has been booked for repairs

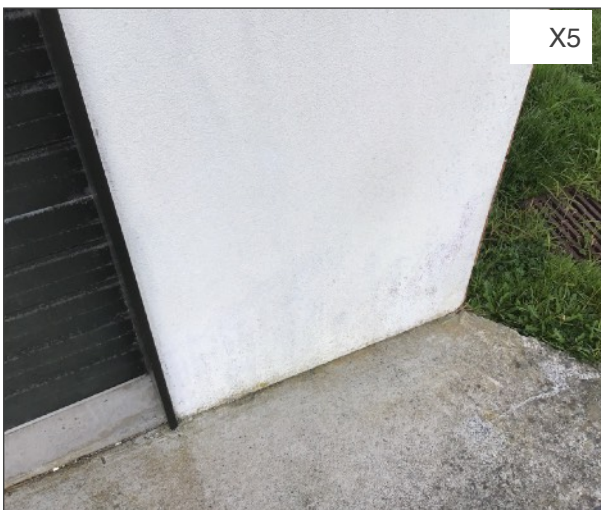
Cladding - Remedial repairs and maintenance

The plaster cladding needs to be painted to keep the cladding sealed and prevent moisture causing damage to the wall framing.

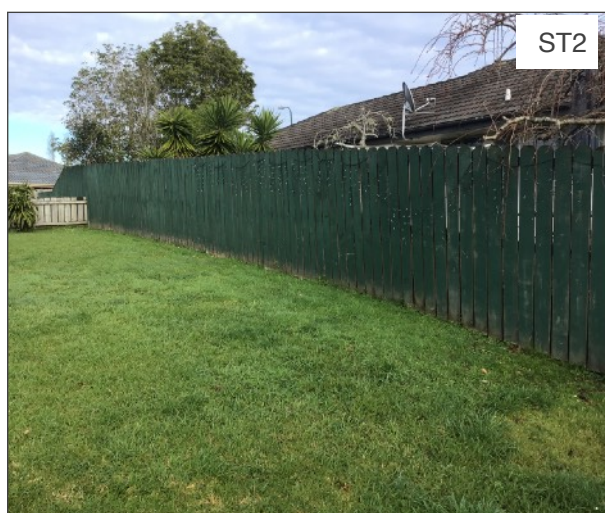
Fencing style

Normal movement found from the age of the fences

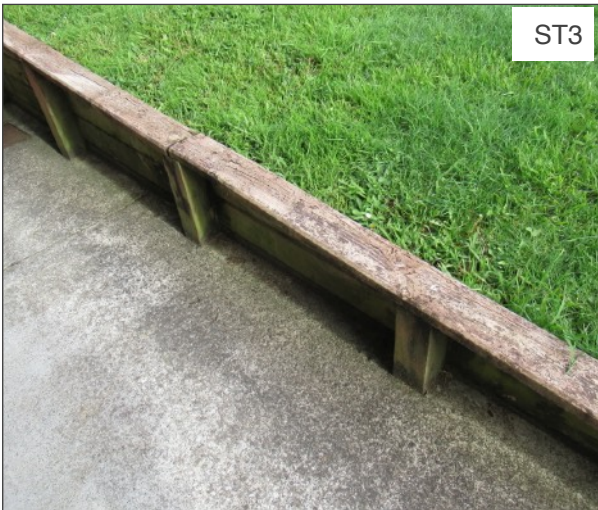
ST3

Retaining wall

Some rot showing on the top board

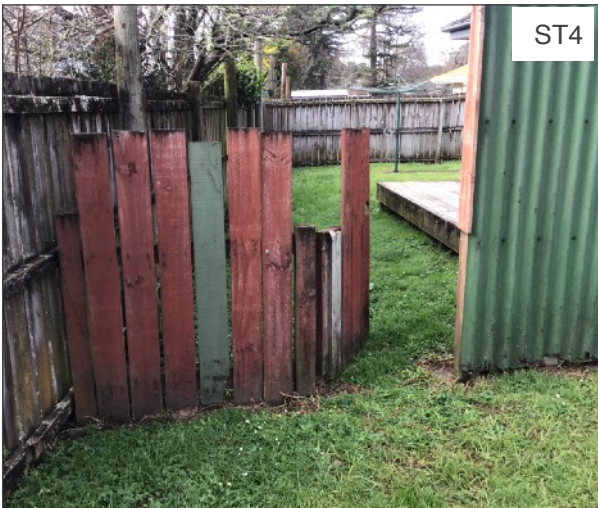
ST4

Fencing style

This gate is difficult to open. Repairs are required

Any additional comments	Action required
	Minor repair

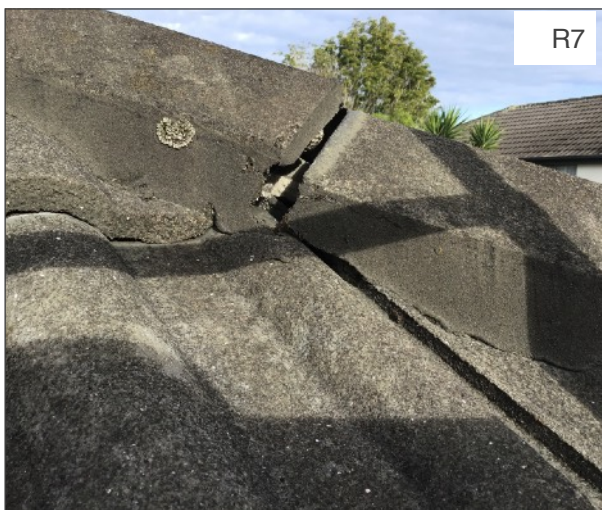
R7

Hip & Ridges

This hip tile on the north west corner has slipped down. A roofing contractor is required to repair to ensure the dwelling remains water tight

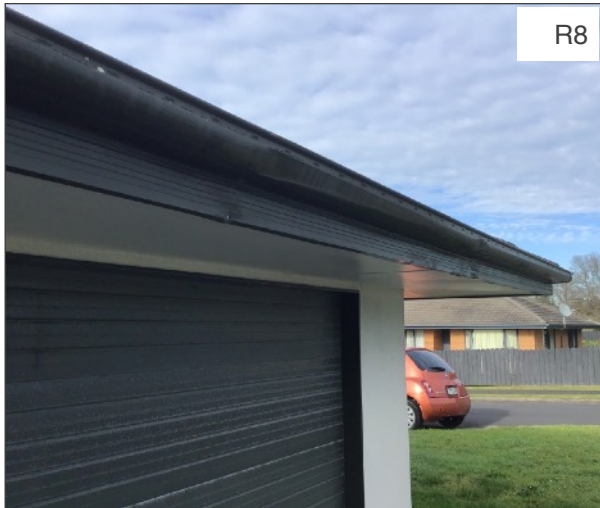
R8

Fascia gutter

Cosmetic damage to the fascia and gutter noted here

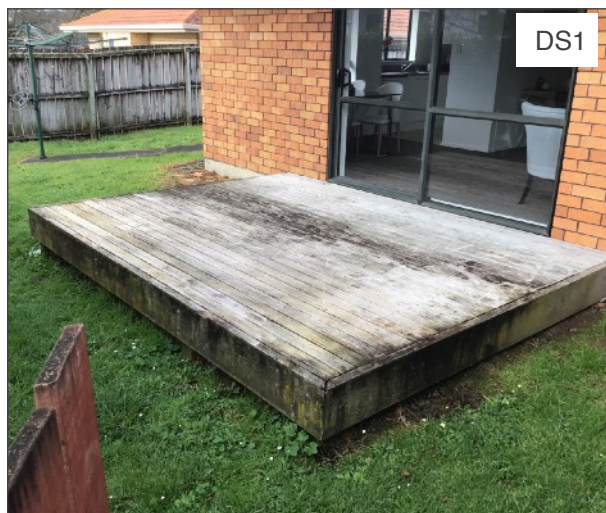
DS1

Deck or balcony style remedial work

Deck appears to be in reasonable condition -Some rot found - Maintain deck to minimise failures in the future

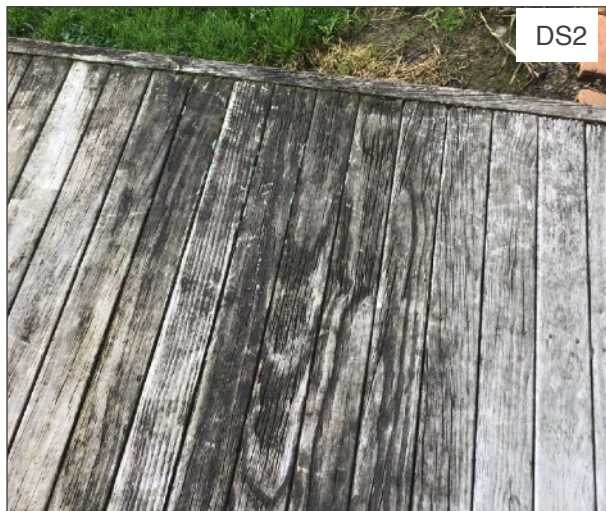
DS2

Deck or balcony style remedial work

Deck appears to be in reasonable condition -Some rot found - Maintain deck to minimise failures in the future

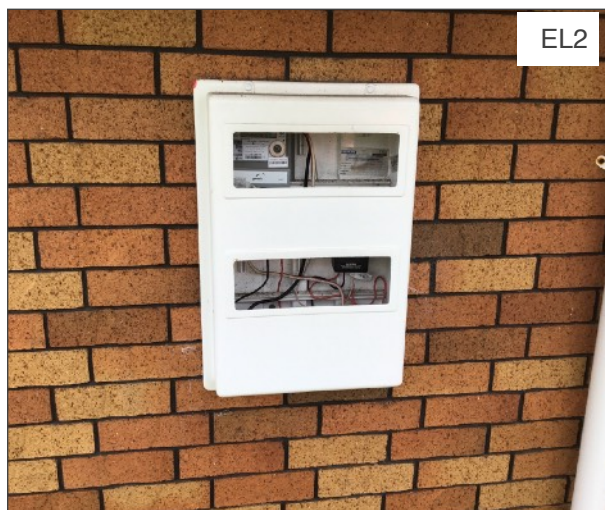
EL2

Main panel

Plastic window is missing and needs to be replaced to keep water out of the power box

Any additional comments	Action required
	Repair required

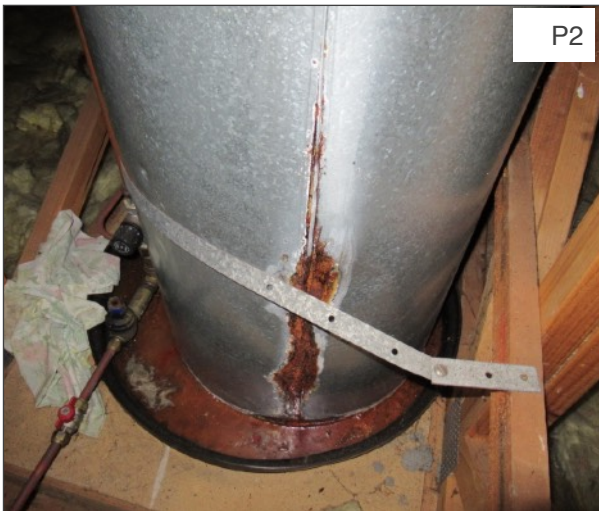
P2

Hot water cylinder

The hot water cylinder is severely damaged and in need of replacement before it fails causing water damage to the dwelling

Any additional comments	Action required
	Immediate repair
