Pre Purchase Inspections Mobile: 021 7289 25 Work: 0800 33 7373 <u>www.dependable.co.nz</u> ryan@dependable.co.nz

Just up the road

Auckland Building Condition Assessment

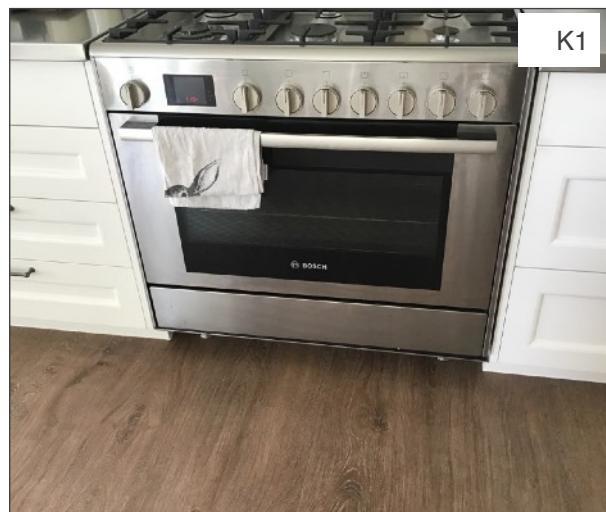
Oven is fitted and functional, but not fully tested

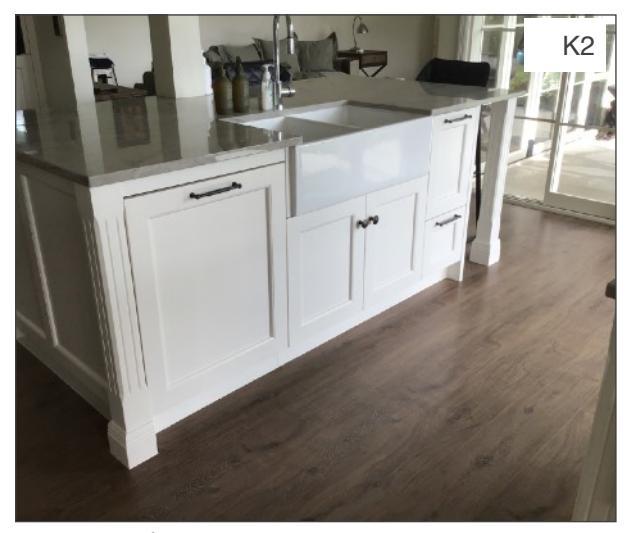
Cabinetry

No water damaged areas found Hardware all working

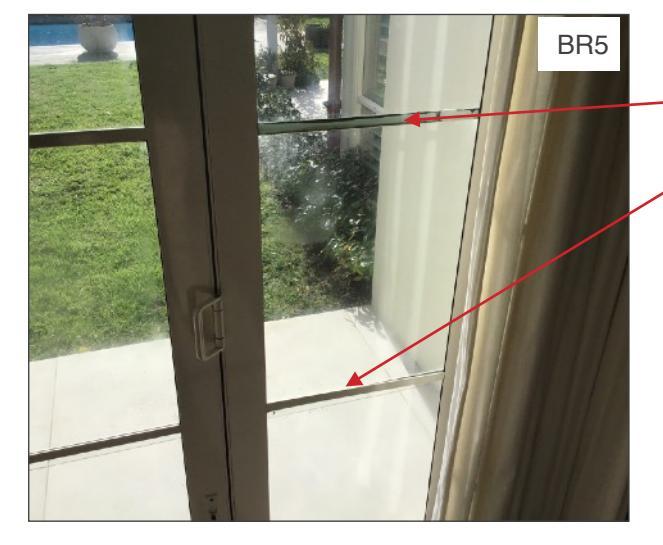
General

There is decorative glazing bead missing from this joinery and another is loose

Any additional comments	Action required
	Minor repair

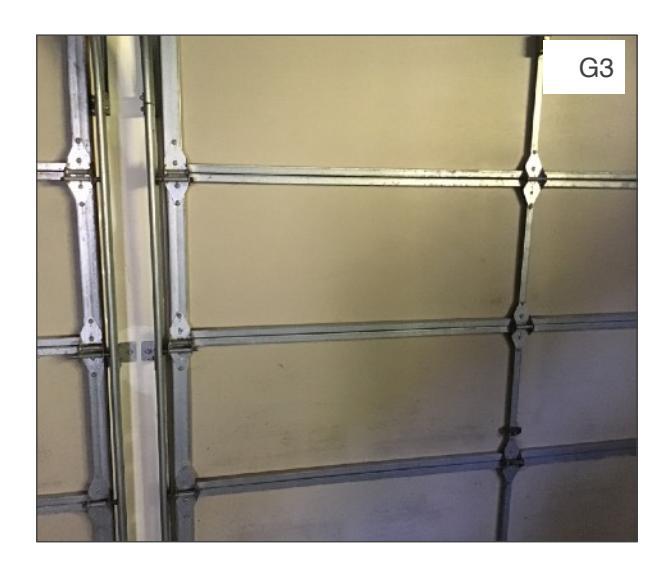
General

There are two screws missing from these hinges

Any additional comments	Action required
	Minor repair

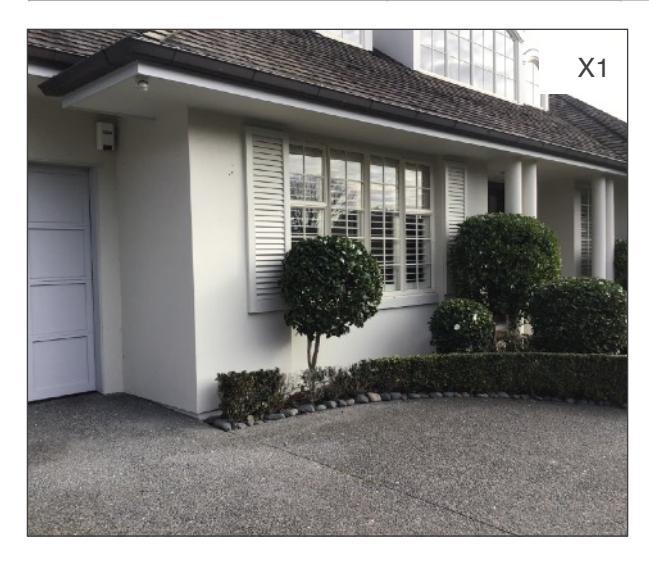
Cladding profile 1

Cladding profile appears well installed and adequately maintained with no major issues

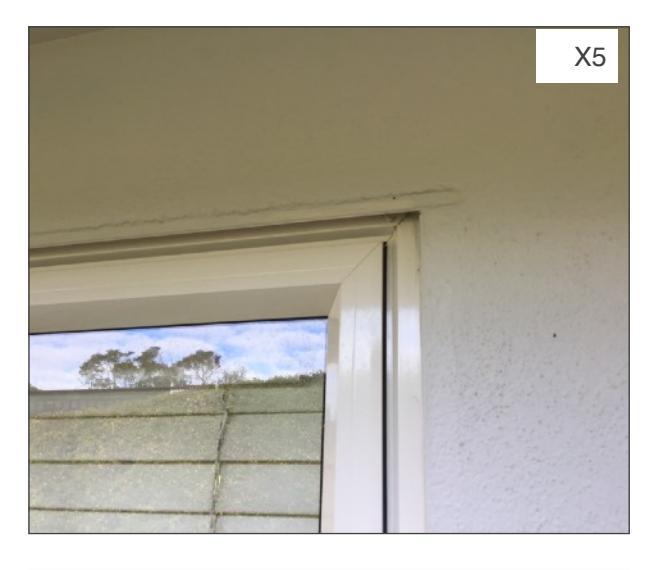
Joinery doors and windows style and remedial repairs

Head flashings have been installed to deflect water away from the joinery

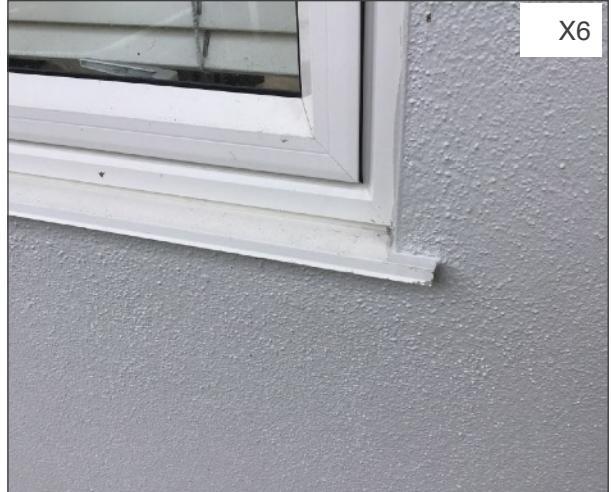
Joinery doors and windows style and remedial repairs

Sill flashings have been installed to deflect water away from the joinery

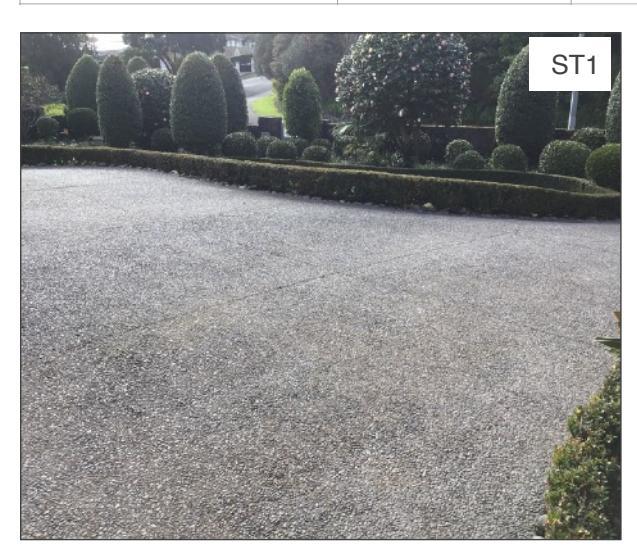
Driveway style and remedial repairs

Minor cracks found

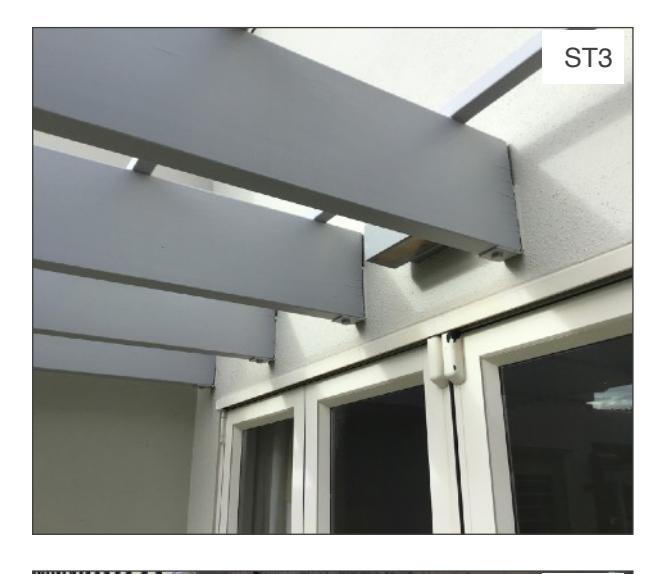
Pergola is performing well with no rot found

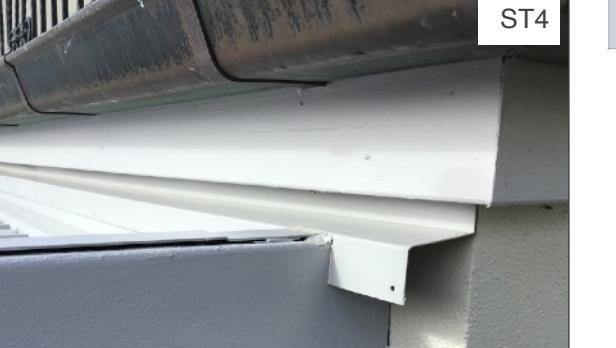
Pergola

Appropriate flashings have been installed during the installation of the pergola

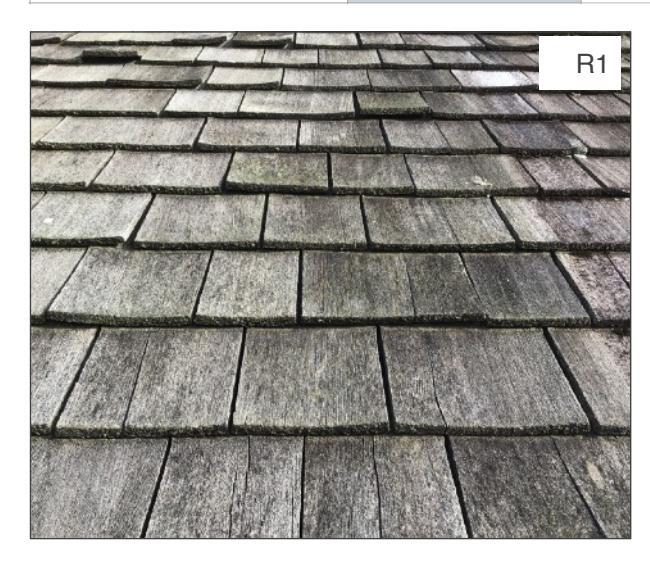
Roof profile and remedial work

Lower roof only inspected

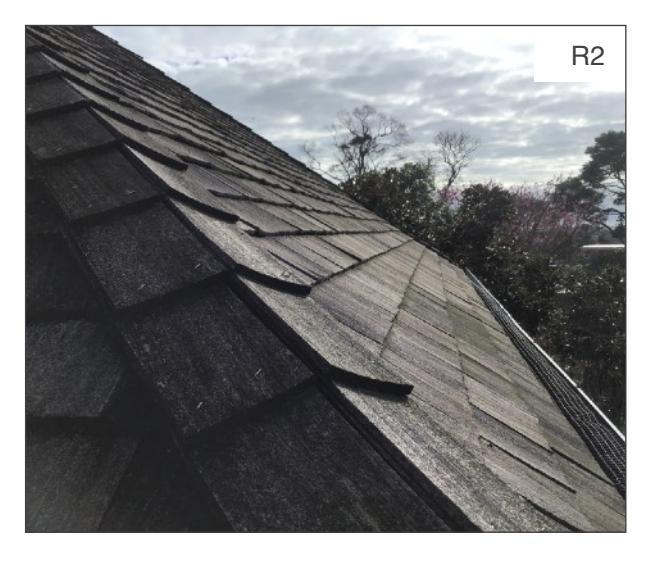
Roof profile and remedial work

Roofing profile appears to be performing well for the age of the roof

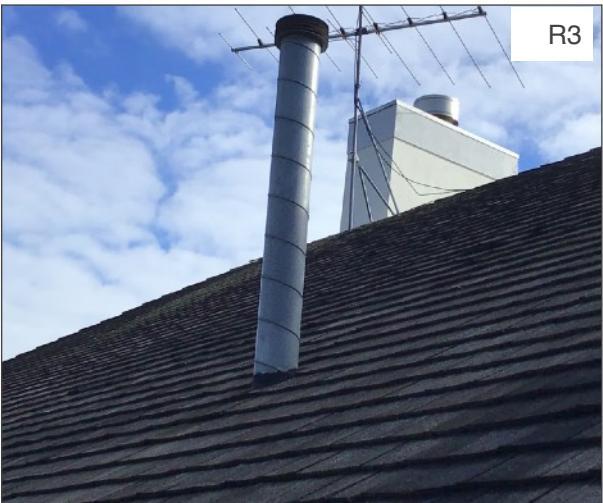
Roof penetrations

Penetrations appear to be all sealed at time of inspection These penetrations must be checked every year as an ongoing maintenance schedule

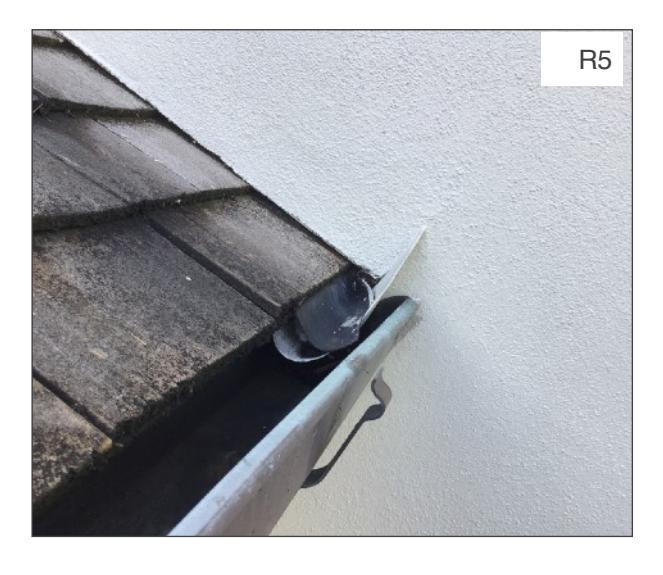
Gutter to wall junctions

Kick out flashings have been installed to direct the flow of water away from the internal wall framing

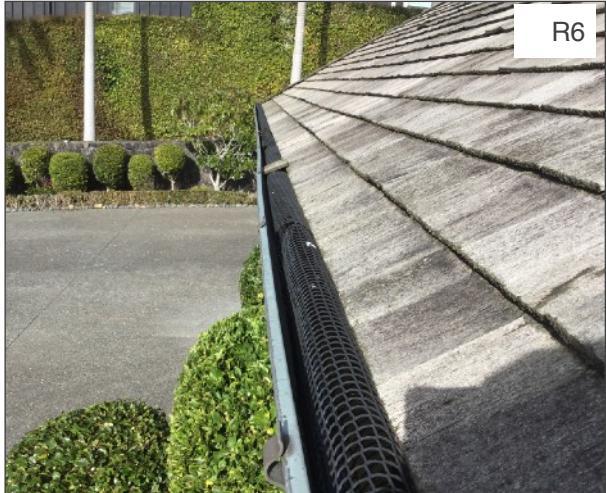
Internal gutters and external gutters

Gutters appear to be performing well at time of inspection

All gutters should be cleaned out twice a year to prevent long term rust or overflowing of the gutter system in to the roof or wall space

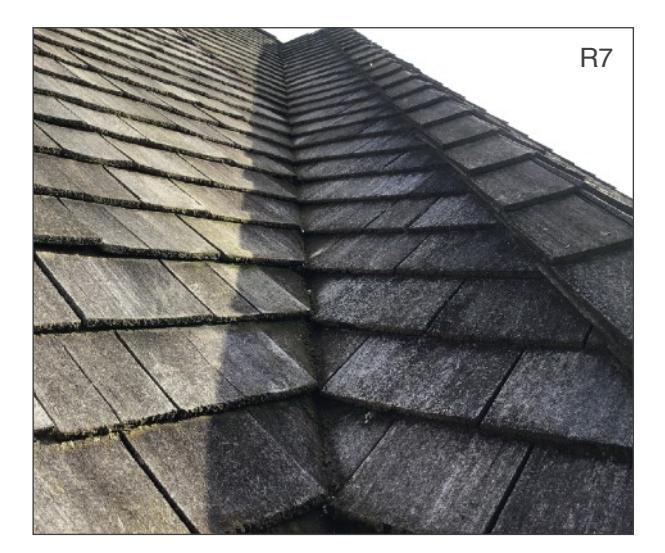
Roof valley

Valleys appear to be performing well

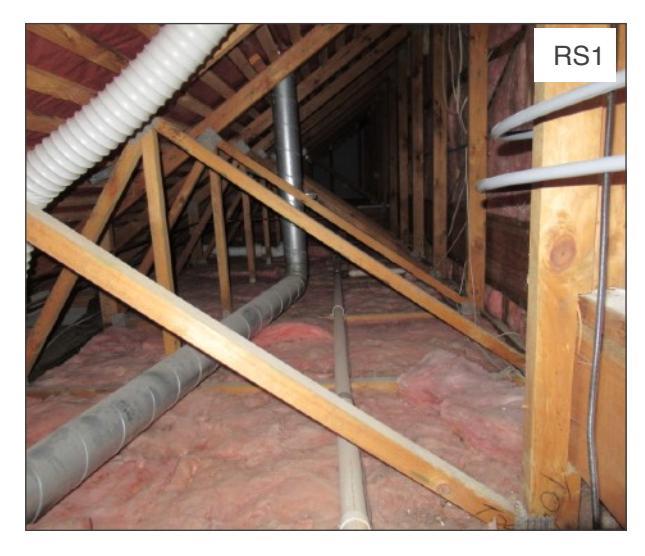
Roof space

Roof framing appears adequately constructed with no noticeable defects observed

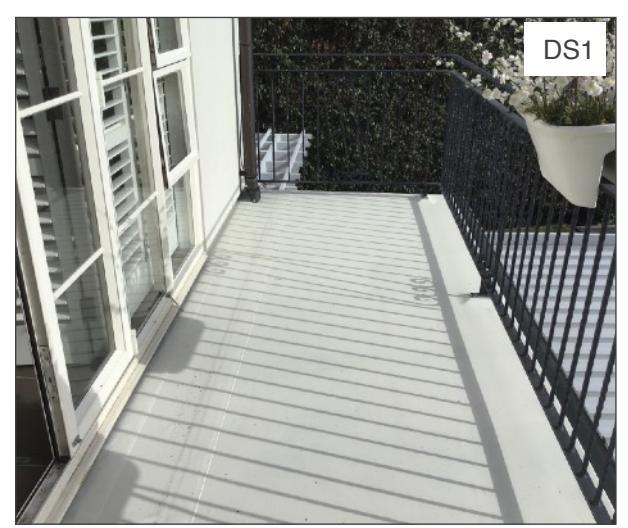
Deck or balcony style remedial work

This style of deck does not have a cavity drainage system This should be monitored each year for deterioration and weather tighness issues

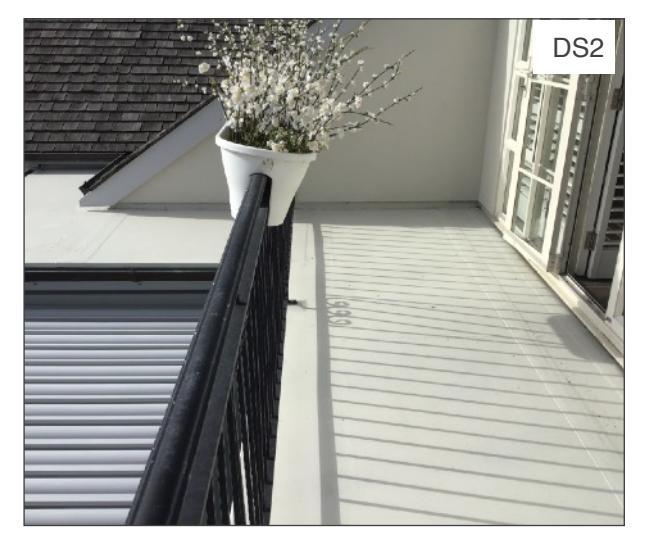
Deck or balcony style remedial work

This style of deck does not have a cavity drainage system This should be monitored each year for deterioration and weather tighness issues

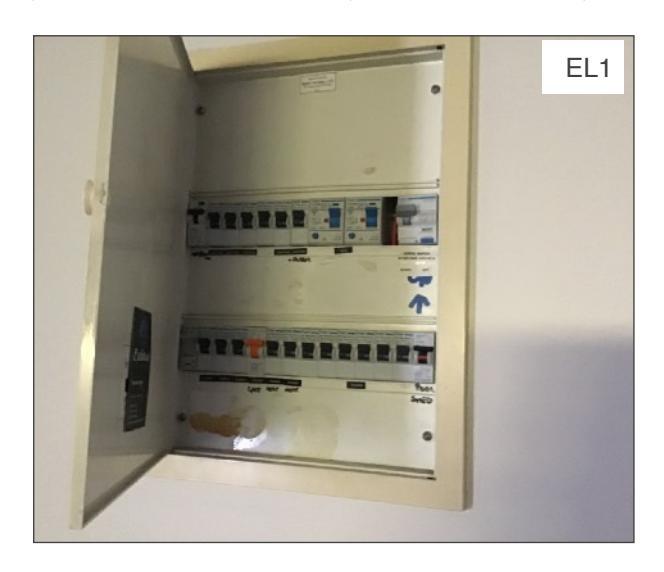
Distribution panel

Trips switches fitted - All labelled - No issues found

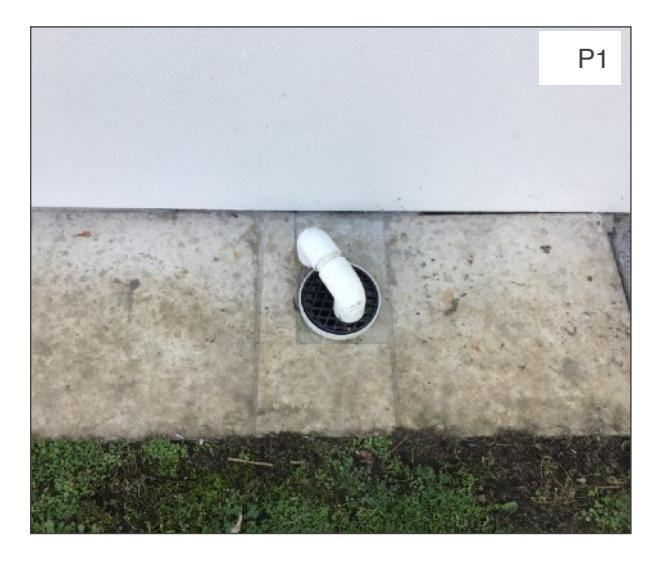
Gully Trap

Lids fitted - Waste flowing

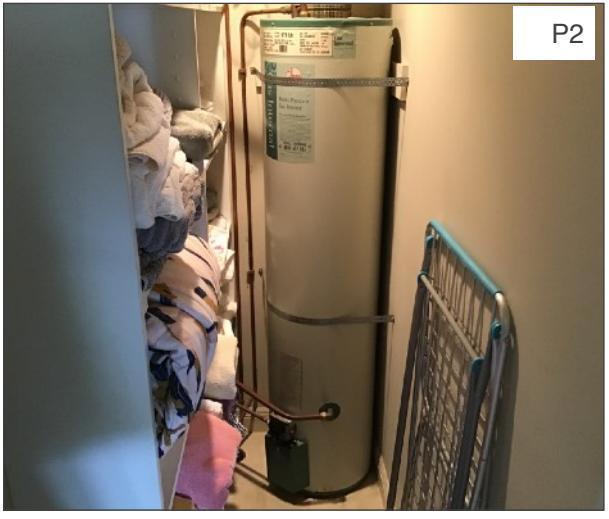
Hot water cylinder

Hot water system is functioning well - No leaks found at time of inspection
